# **Dismantling of obsolete installations and glove boxes**

**Melis Gustaaf - Radiation Protection Officer I.R.M.M.  
Cretskens Pieter - Engineer TECNUBEL**

#### **EUR Report 21861 EN**

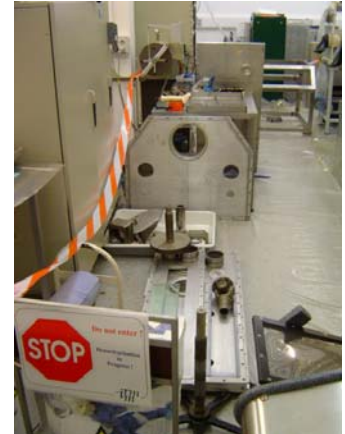
- All parts were removed piece by piece, degreased and cleaned. After drying, absorbant paper towels were treated as combustible nuclear waste.
- Checks for alpha and beta contamination with direct measurement.
- Wipe tests were taken over 100% of the surfaces and registered.
- Wipe tests measured in the R.S. laboratory.
- Where contamination was detected, the object was decontaminated, measured again and new wipe tests were taken.
- When all the results were negative ( $\alpha < 0,04 \text{ Bq/cm}^2$  and  $\beta < 0,4 \text{ Bq/cm}^2$ ) these parts were immediately removed from the controlled area to a buffer storage area.
- A second check was made by the Authorized Control Body, AV Controlatom.

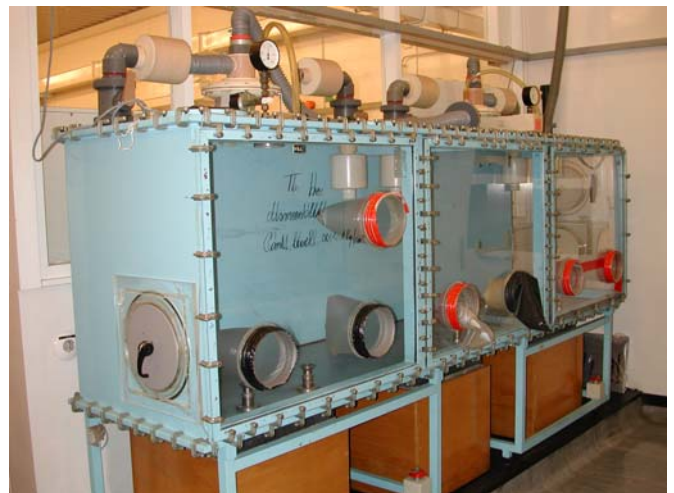
This is a large glove box made up of 3 units and used for different types of weighing: powders, liquids, solids.

**This box was used to demonstrate metal cutting with an electric saw. For fire safety reasons, grinding, abrasive cutting or use of heat or spark generating devices were not allowed.**

- Removal of all the outside filters, valves, electric connections...to check for contamination in room 531.
- A tent with SAS (airlock) was erected around the box.
- Work started with cutting the upper side, working downwards.
- The front plexi-glass windows were cut in pieces, packed and moved to room 531 for contamination checks and possible decontamination. All the walls were cut into smaller pieces to be decontaminated or shipped as RA waste.

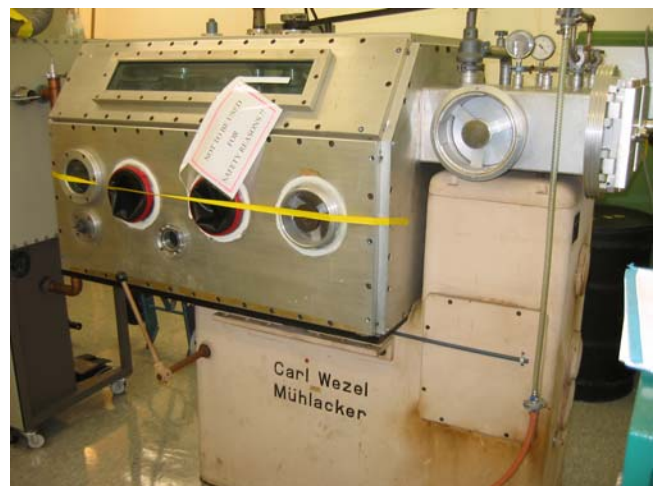
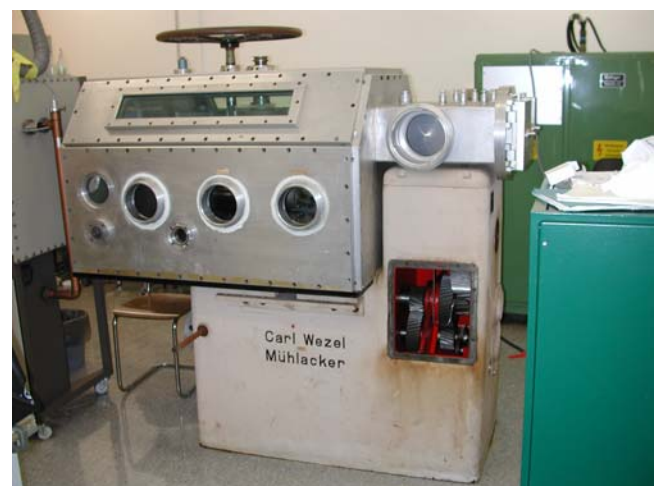
This roller was used to make foils of U alloys.

Contamination level:  $< 1 \text{ Bq } \alpha / \text{cm}^2$ .

- No tent, only PE foil and demarcation leading to fume hood.
- All the side panels were removed and transported to the fume hood for decontamination. Tests showed that no contamination was left.
- All the checked items were stored on the table next to the fume hood. After confirmation of no contamination, they were immediately shipped outside the controlled area to the buffer storage.

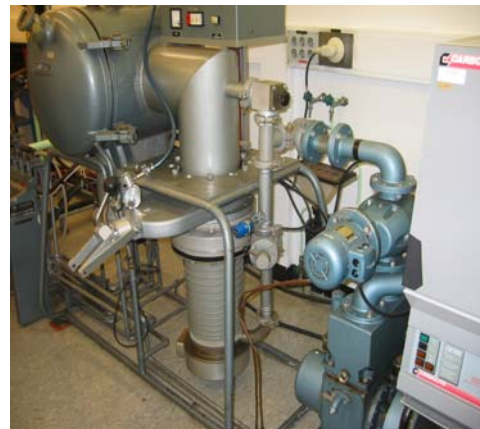
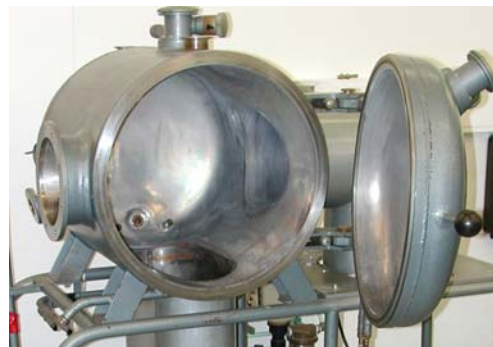
This oven was used to make U alloys.

- Vacuum pumps dismantled and checked.
- Water cooling system dismantled and checked.
- Oven completely emptied and checked.

- No tent, only PE foil and demarcation leading to fume hood.
- Same procedure was followed as for the rolling device.

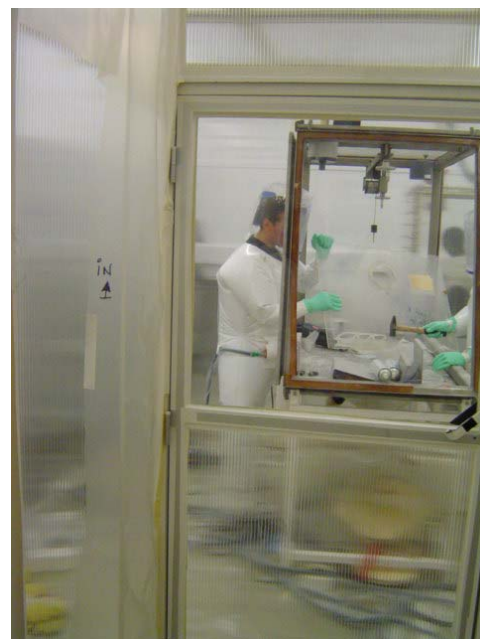
The dismantling campaign was carried out in two types of tents depending on the contamination inside the glove boxes. The most common glove boxes were dismantled in a tent constructed with hard surfaced polycarbonate plates. It was erected inside the lab, around the glove boxes using the standard technique with SAS, independent breathing apparatus, hand and foot monitor at the exit of the tent.

For glove boxes with higher contamination, the same principle was used but with a second glove box tent inside to prevent the spreading of contamination.

- The support that carries the glove box was taped up for removal afterwards. All outside parts were removed piece by piece and checked for contamination.

- The box was dismantled starting from the top, down. All parts were cut into pieces, packed in plastic and separated in different barrels.
- The RS responsible kept a detailed record of the materials in different barrels.

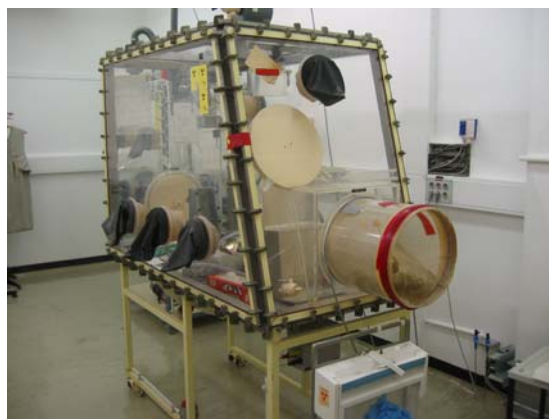
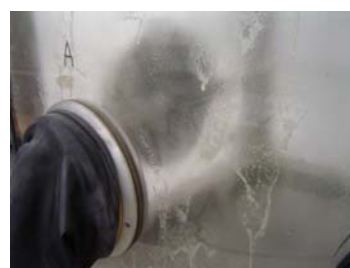
This glove box was mainly used for repacking and heavy duty punching.

It has a very wide opening for bagging out giving the possibility for handling large targets.

Contamination level: from 2 to 22 Bq / cm<sup>2</sup>.

- Punches were dismantled, bagged out and stored.
- Waste bagged out.
- Fixation of contamination with adhesive spray. Some years ago, several types of fixation sprays (varnish, plastic spray, etc.) were tested and the adhesive spray with contact glue gave no chemical reactions. The advantage being that untreated spots are easier to detect.

- A tent was erected around the glove box.
- The support frame that carries the glove box, was taped up for removal afterwards: no RA waste.
- The box was dismantled starting from the top, down. All parts were cut in pieces and separated.
- After the work, the tent was decontaminated and checked for re-use.

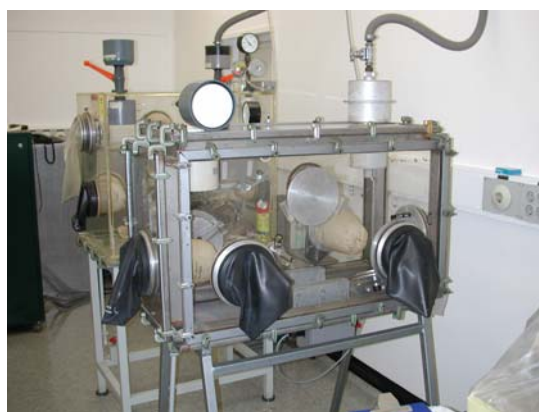
Glove box H 2 contained a small manual roller for  $^{239}\text{Pu}$  foils.

Contamination inside from 10 Bq  $\alpha$  / cm<sup>2</sup> to 30 Bq  $\alpha$  / cm<sup>2</sup>.

- Roller was dismantled and stored as RA waste. The waste was marked as “denuclearisation waste” in separate barrels.
- Box completely emptied.
- Fixation of contamination with adhesive spray.

- This glove box was disconnected and transferred to room 521 for dismantling in the same tent as H48.

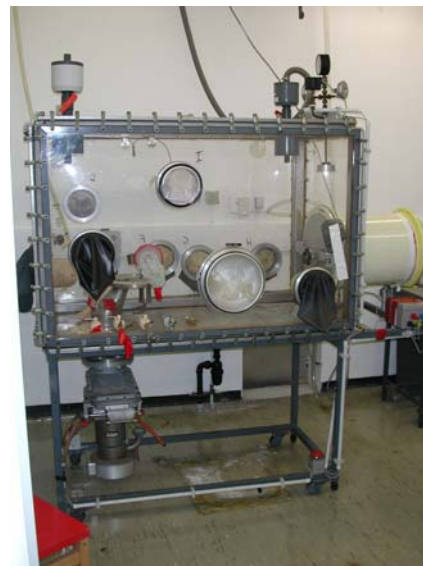
Glove box H1 was used to make  $^{239}\text{Pu}$  and  $^{237}\text{Np}$  alloys with levitation melting.

Contamination level for  $\alpha$  from 10 Bq / cm<sup>2</sup> to 33 Bq/cm<sup>2</sup>

- Two pumps outside.
- Inside oven, glass vacuum installation, tools.

- Dismantling of one pump.
- Bagging out all the tools and materials.
- Making of two large bags to bag out the large oven and glass clock through the SAS.
- Fixation of the contamination.

- A tent was erected around the glove box and pumps removed before dismantling.

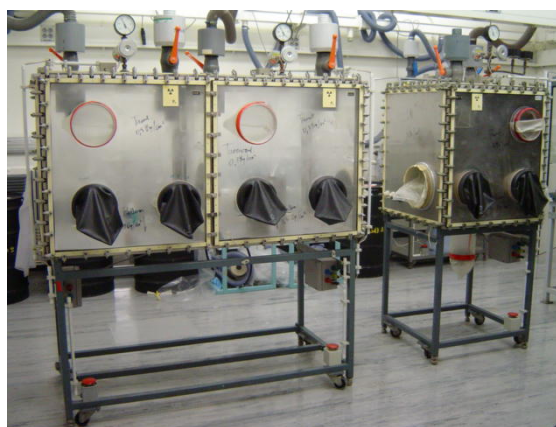
These glove boxes were used for preparing synthetic mixtures and connected as a “train”.

Contamination level: from 0,3 to 90 Bq / cm<sup>2</sup>.

- Balance was dismantled and sealed out.
- Waste sealed out.
- Fixation of contamination.

A tent was erected around the glove boxes. Work started with H101 and H 102 because of lower contamination level.

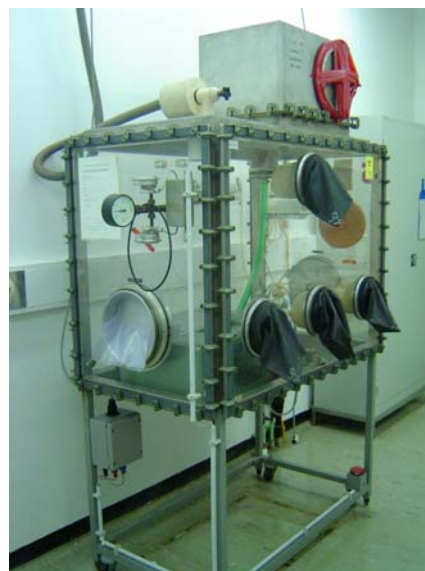
This glove box was used for weighing “higher” activities and  $^{239}\text{Pu}$  powders.

Contamination level: from  $30 \text{ Bq } \alpha / \text{cm}^2$  to **1000 Bq  $\alpha$  / cm<sup>2</sup>**.

- Waste sealed out.
- Concrete support under box removed.

- A “tailor” made glove box with protective tent was erected around the glove box.

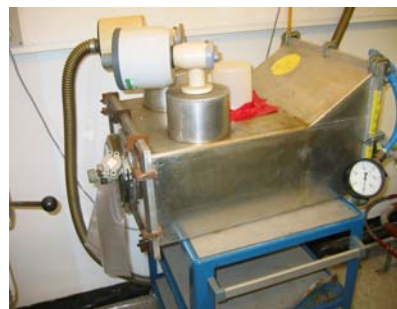
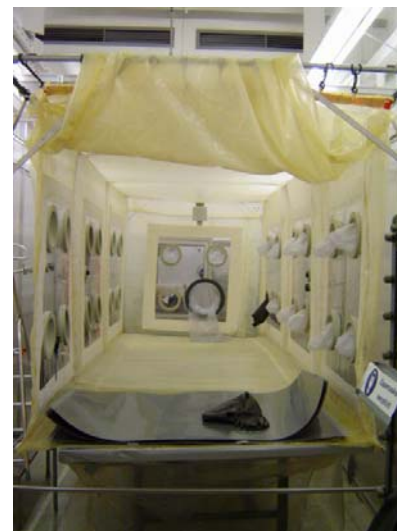
This glove box was used for compressing “higher” activities Pu, U,  $^{237}\text{Np}$  powders. It was in very bad condition and had to be handled with care.

Contamination level: from  $60 \text{ Bq/cm}^2$  to **900 Bq/cm<sup>2</sup> for  $\alpha$** .

The use of this “tailor” made glove box tent was a first in Belgium. No unexpected problems occurred thus being a very good experience for the IRMM and the contractor. A detailed description can be found in the report (ref.60.216/030/M/KL/PCR) made by the co-writer Pieter Cretskens from Tecnubel, chapter 9 from pages 36 to 50.

- Waste bagged out.
- Fixation of contamination.

Was dismantled in glove box tent in room 523.
